# 316L+Q345R 双金属复合板压力容器的点蚀

陈庆国<sup>1</sup>, 谭川江<sup>1</sup>, 童 根<sup>1</sup>, 宋成立<sup>2</sup>, 王 瑶<sup>1</sup>

## Pitting of 316L+Q345R Bimetallic Composite Plate Pressure Vessel

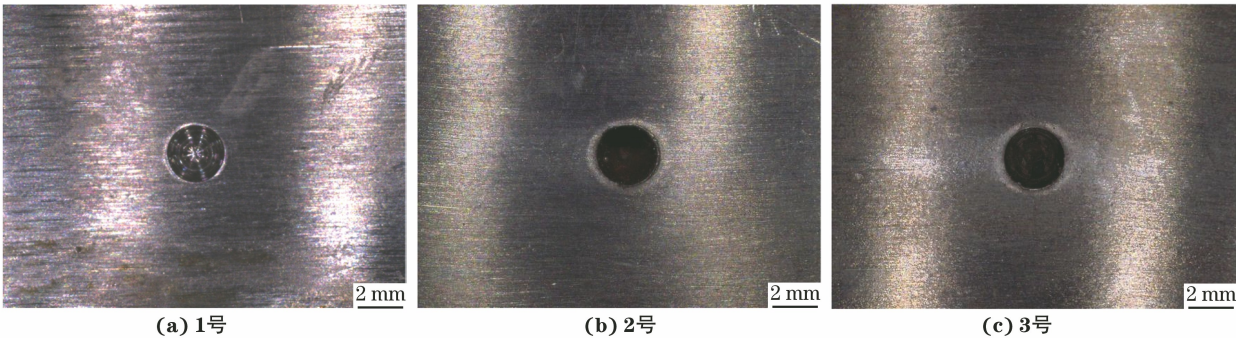
图 2 浸泡腐蚀试验后 3 个试片的点蚀宏观形貌

由图 2 可知:所有预制的点蚀坑上部边缘一周均呈现较为规则的圆形,未见明显腐蚀扩展迹象,也未萌生新的点蚀;1 号试片预制的点蚀坑内可见金属光泽,2 号和 3 号试片点蚀坑内可见明显的腐蚀产物附着。

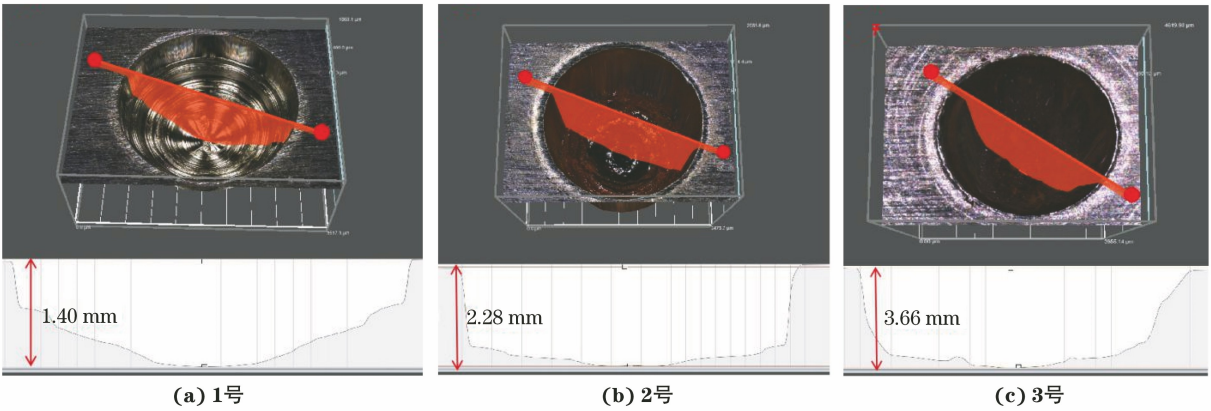
由图 3 可知:1 号试片预制的点蚀坑处可见明显的金属加工痕迹,3D 成像中呈现圆锥形,点蚀坑深度未发生变化,表明点蚀未发生明显扩展;2 号和 3 号试片点蚀坑内部附着了一层腐蚀产物,3D 成像

与 1 号试片呈现的圆锥形相差较大,点蚀坑深度因腐蚀产物的附着而减小。

图 3 浸泡腐蚀试验后 3 个试片的点蚀坑 3D 图像

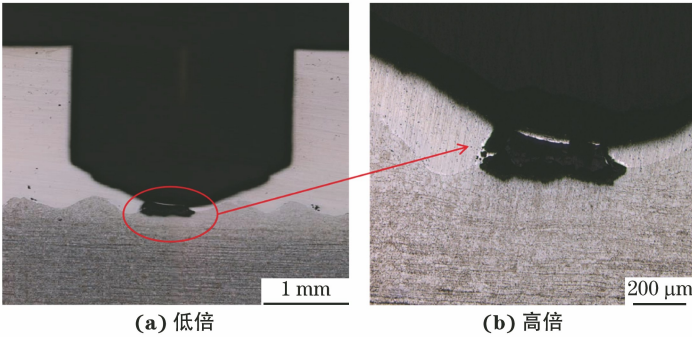
由图 4 可知,2 号试片预制的点蚀坑底部刚好触及 Q345R 钢层,Q345R 钢优先发生了腐蚀,形成

图 4 浸泡腐蚀试验后 2 号试片的点蚀坑截面形貌

一个孔洞,孔洞的深度约 0.15 mm,点蚀速率为 3.911 mm/a。

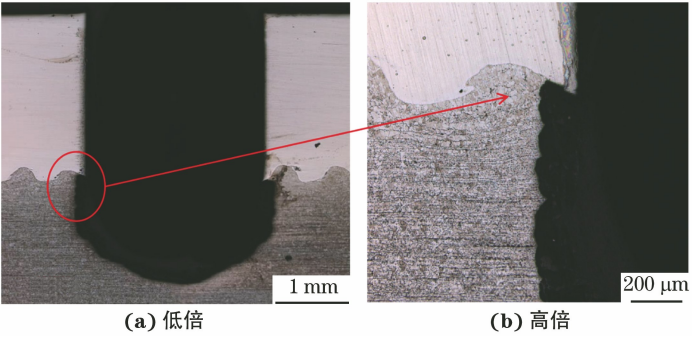
由图 5 可知,3 号试片预制的点蚀坑已完全穿

透 316L 不锈钢层,Q345R 钢层优先发生了腐蚀,并不断向周围扩展,测得点蚀坑底部金属减薄了约 0.19 mm,点蚀速率为 4.954 mm/a。

图 5 浸泡腐蚀试验后 3 号试片的点蚀坑截面形貌

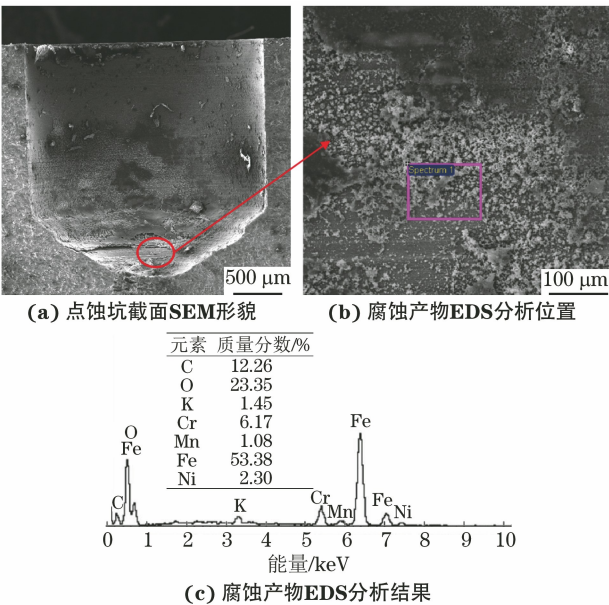
由图 6 可知:2 号试片开孔处的腐蚀产物主要集中于点蚀坑底部,腐蚀产物较薄且不致密;腐蚀产物主要成分为 C、O、K、Cr、Mn、Fe 和 Ni 元素,推断存在 CO<sub>2</sub> 的腐蚀产物 FeCO<sub>3</sub>,Cr、Fe 和 Ni 都属于金属基体元素。

图6 浸泡腐蚀试验后2号试片点蚀坑沿直径剖开后的截面SEM形貌和腐蚀产物EDS分析位置及结果

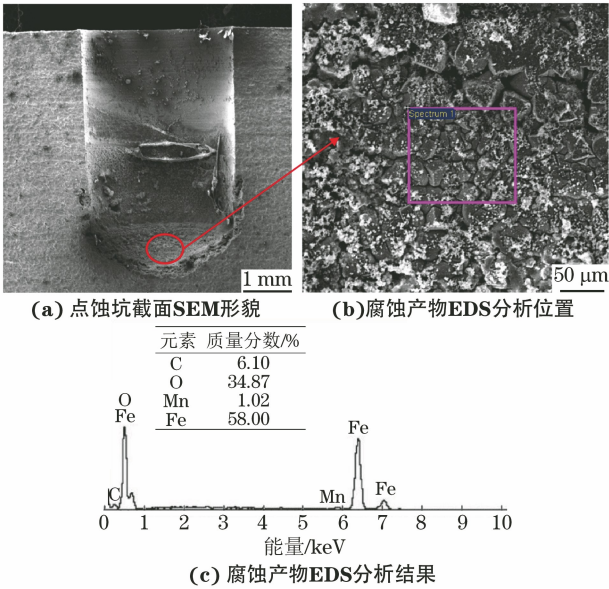
由图 7 可知:3 号试片预制的点蚀坑底部腐蚀相对严重,出现了凹凸不平的金属损失形貌,但上部

不锈钢层较为完好;坑底附着了一层较厚且相对紧密的腐蚀产物,其成分为 C、O、Mn 和 Fe 元素,推断主要是 CO<sub>2</sub> 的腐蚀产物 FeCO<sub>3</sub>。

图7 浸泡腐蚀试验后3号试片点蚀坑沿直径剖开后的截面SEM形貌和腐蚀产物EDS分析位置及结果

(2) 建议双金属复合板压力容器在服役中应定期开展无损探伤,及时排查新萌生的点蚀,并对点蚀深度进行精确测量,当点蚀深度超过不锈钢层厚度时需要立即补焊修复,确保复合板压力容器的安全风险可控。
