# Incoloy 825 镍基高温合金电子束焊工艺及 接头组织与力学性能分析

**摘要:** 采用电子束焊, 对空冷器管箱 Incoloy 825 镍基高温合金进行对接焊试验. 通过对焊接接头的组织观察, 并结合拉伸力学性能以及接头的冲击韧性等试验, 分析镍基高温合金电子束焊接头的组织和力学性能. 结果表明, 采用电子束焊焊接镍基高温合金可以得到良好的焊接接头, 焊缝区组织由大片等轴晶和少量柱状晶组成; 焊缝区没有出现明显的元素烧损现象; 焊缝、热影响区硬度达到母材硬度值; 焊缝接头抗拉强度达到 600 MPa, 接近母材抗拉强度, 接头断裂形式为韧性断裂; 焊缝和热影响区的冲击吸收能量高于母材区, 其中焊缝区的冲击吸收能量达到了 262 J, 冲击断面形貌为韧窝状.

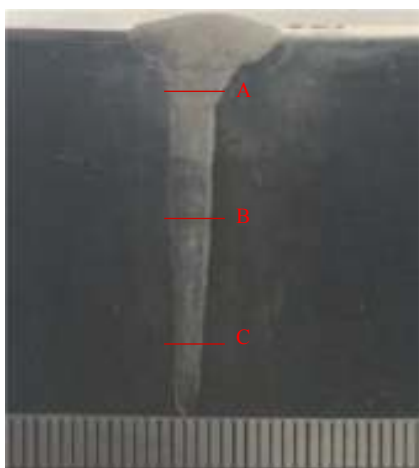
图 1 接头横截面宏观形貌

Fig. 1 Section morphology of welded joint cross section

为研究电子束焊对焊接接头组织及性能的影响,对试样进行金相组织分析。经过打磨抛光和腐蚀完成金相试样的制备。所选用的腐蚀液为浓盐酸和浓硝酸按体积比为 3:1 配成的王水,接头横截面宏观形貌如图 1 所示,焊缝形貌整体呈现“钉字形”,并且从图中可以看出,焊接接头截面无可见杂质、气孔、裂纹等缺陷存在,实现了很好的冶金接合。图中 A, B, C 位置的熔深熔宽比分别为 33:4, 33:3, 33:2, 没有明显的变形。

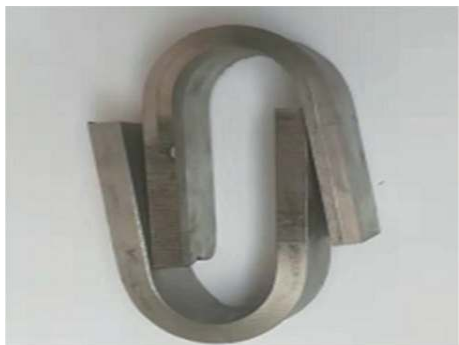
图 10 弯曲试样

Fig. 10 The simples for bending test

为测试焊缝处承受弯曲应力的能力,对试样进行了弯曲试验,并观察焊缝处是否失效,图 10 为焊缝处的内外弯曲试验,内弯试样和外弯试样均没有出现开裂,基体均完好,电子束焊焊缝强度基本符合要求。
