脱甲烷塔塔顶冷凝器甲烷出口线钢铝转换接头泄漏原因分析

摘要:某石化公司裂解装置运行过程中, 乙烯精馏塔塔顶甲烷含量持续上涨, 经排查为脱甲烷塔冷凝器甲烷氢侧泄漏所致, 更换新的钢铝接头后, 甲烷含量逐渐下降满足生产要求。对运行状况进行分析, 对接头开裂处样品进行宏观检查、金相分析、硬度检测和扫描电镜观察, 开裂主要原因是日常开停工期间冷凝器升降温速率控制不当、钢铝转换接头存在制造缺陷等。通过制定严格升降温速率操作方案, 严格细化和优化工艺操作, 优化相应设备的操作规程, 达到装置长周期平稳运行的目标。

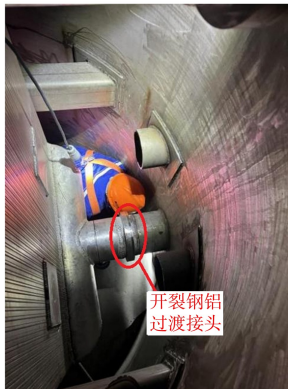
图1 泄漏部位示意

2024年4月, 某石化公司乙烯精馏塔塔顶甲烷含量持续上涨, 经分析排查, 判断脱甲烷塔塔顶冷凝器存在内漏。停工确认泄漏部位为脱甲烷塔塔顶冷凝器甲烷氢出口线钢铝转换接头上部的爆炸焊复合层发生开裂(见图1)。

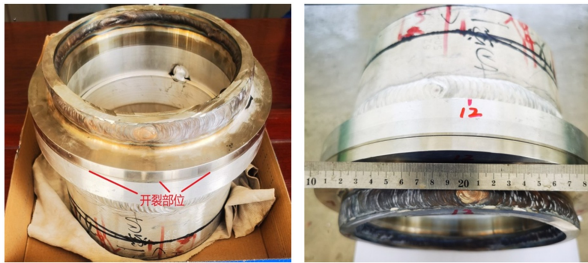
图 2 钢铝接头复合层开裂情况

对钢铝转换接头整体和泄漏部位进行宏观检查,失效钢铝转换接头上部爆炸焊复合层开裂缝隙宽约 0.5 mm,开裂长度约为接头法兰周长 1/4,转换接头整体及各成型复合层未见异常变形,表面未见腐蚀特征,初步判断钢铝接头复合层开裂为脆性断裂(见图 2)。

脱甲烷塔塔顶冷凝器甲烷出口线钢铝转换接头开裂原因是: 钢铝接头制造时 Ni - Ti 爆炸焊工艺参数偏大导致复合区产生过多液体金属形成气

孔、夹杂、空隙、裂纹和脆性组织等微小缺欠, 在长期运行使用中, Ni - Ti 爆炸焊复合区微小缺欠逐渐扩展开裂连接形成复合区结合强度最薄弱部位, 此外钢铝转换接头除在运行时受到内外压力、各类重力、支撑反作用力、连接管道和其它部件的作用力影响, 还受到多次开停工温度梯度或热膨胀量不同引起的作用力以及压力波动冲击载荷等复合应力的影响, 当管系轴向拉应力超过 Ni - Ti 接头复合区最薄弱处的承载强度时, 转换接头发生脆性开裂。
